## The Unavoidable Repair: Pedal Shaft and Bushing Replacement on TDs and TFs

by Jeffery Delk, Southeastern MG T Register

**mgTalk. Vol. 37, No. 1, January 2011**

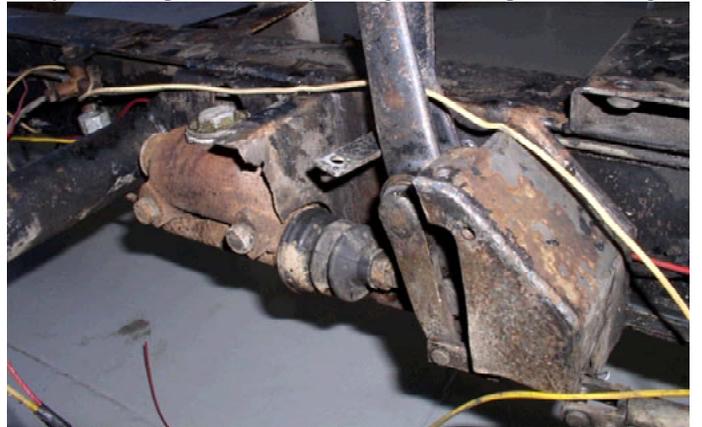
An indication of this frustration is that some boxes have been badly hacked up and cut away during earlier "repairs" (see Fig. 2).

**Fig.2 The remains of a pedal box that has been butchered during a previous "repair".**

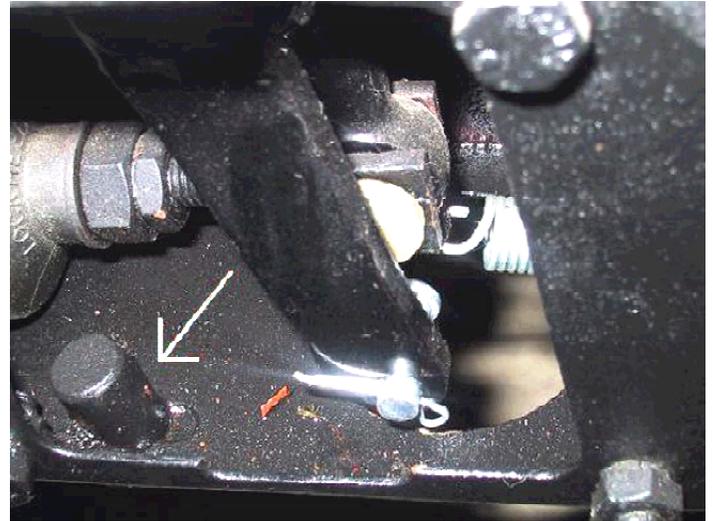
The early pedal box, as found on TDs prior to Nov. 1952 (TD 22251), lacks the clutch stop that is on later cars (see Fig. 3).

**Fig. 3** View inside the pedal box showing the stop-pin for the clutch, the recessed area at the base of the inspection cover opening (to allow for the passage of the clutch lever arm, and large, round opening found at the bottom of the later-style pedal box (as fitted to later TDs and all TFs).

This clutch stop was fitted at the same time the rod operated clutch replaced the cable operated clutch. The placement of this stop pin prevents the arm from moving too far back, bending the clutch actuating rod, and over extending/stressing the clutch release fingers. If your pedal box has a small hole in the bottom – you are most likely missing your clutch stop pin. The early pedal box also lacks the large round access hole that is found in the bottom of the box on later TDs and all TFs. This large opening greatly aids access and simplifies maintenance and repair. Neither Moss nor Abingdon list a cover plug for this access hole – though a suitable rubber plug with a lipped flange (similar to that found on the later type master cylinder inspection hole) may be used to seal off the opening.

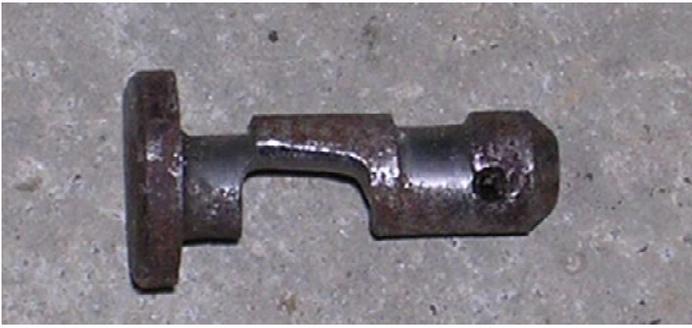
**Fig. 4 Example of extreme wear on a pedal arm clevis pin.**

This is a good time to check the clevis pins for wear – replace these if needed as this will remove some of the lost motion that may exist in the clutch and brake linkages (see Fig. 4).

Also check the clevis pin openings in the pedal arms – if worn, consider welding them up and redrilling for a better fit. The lost motion at the lower end of the arm is greatly magnified as you move up the arm to the actual pedal – so that minimal movement at the base of the pedal arm will actually feel like a great deal of lost movement when placing your foot on the pedal pad during use.

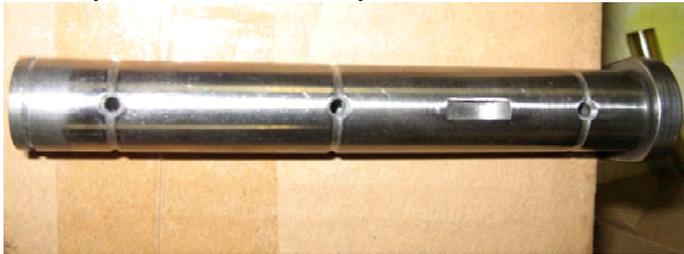
**Fig. 5 Modified shaft for LHD TD/TF: showing the three lubrication grooves and the three upper lubrication holes. The slot for the clutch arm's Woodruff key is shown between the upper lubrication holes for the inner frame bushing and the brake arm bushing.**

After receiving the new replacement shaft, I took it (and a copy of Richard's tech article) to my local machine shop with the request that they modify the shaft by drilling extra lubrication holes and cutting the three lubrication grooves. I decided to have them drill completely through the shaft for each of the three lubrication points – for a total of six lubrication exit points. Once all holes were drilled, the lubrication grooves were cut – one groove for each of the three sets of lubrication holes (see Fig. 5 and 6). This machine work cost \$30 dollars and I consider it money well spent. The six grease holes feature chamfered edges and these aid in distributing the grease once the bushings are in place over the exit holes in the shaft. When I tested the complete assembly on the workbench, I confirmed that, when pressured in by the grease gun, the grease would travel completely around all grooves and would spread out under the surface of each bushing. The tolerances are such that grease would travel to the absolute edge of the bushings. The pumping in of the grease filled the slight bit of clearance between the bushings and the shaft. This made for a very snug fit – just what we are after! With use, I think the coverage will be more than adequate. Richard's article mentions the cross hatch design for the lubrication grooves. I agree that this is the preferred pattern – as it promotes better surface coverage, see Fig. 7. I went with the simple grooves as these were easily cut by the machine shop and I had only one afternoon to modify the shaft before installation.

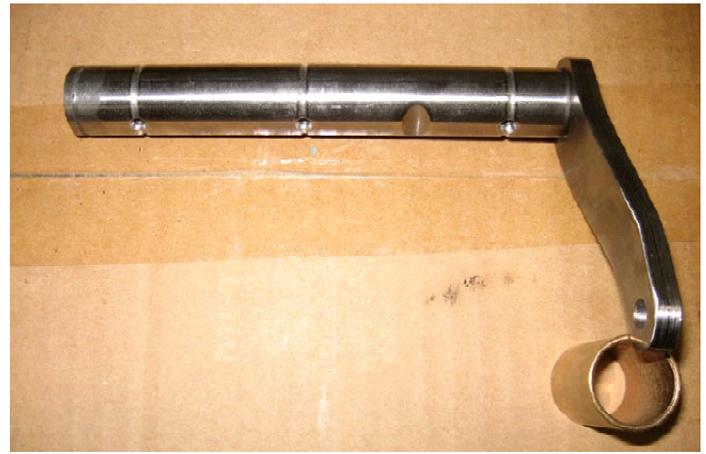
**Fig. 6 Modified shaft for LHD TD/TF: showing the three lubrication grooves, the three lower lubrication holes, and the drop arm for the clutch linkage. The clearance recess for the clutch arm pinch bolt is visible between the lubrication holes for the inner frame bushing and brake arm bushing.**

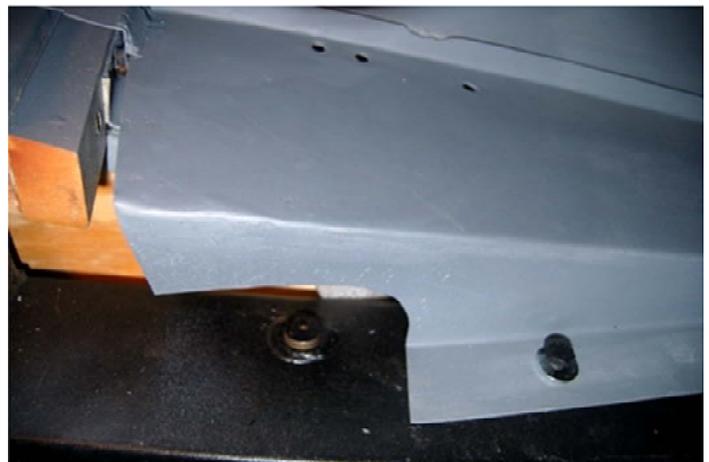
Fig.8 Fender Cutout to allow access to grease fitting on RHD MG TD and TF

The fender will have to be modified on early TDs to allow access to the grease fitting, see Figure 8
