## The Unavoidable Repair: Pedal Shaft and Bushing Replacement on TDs and TFs

by Jeffery Delk, Southeastern MG T Register

**mgTalk. Vol. 37, No. 1, January 2011**

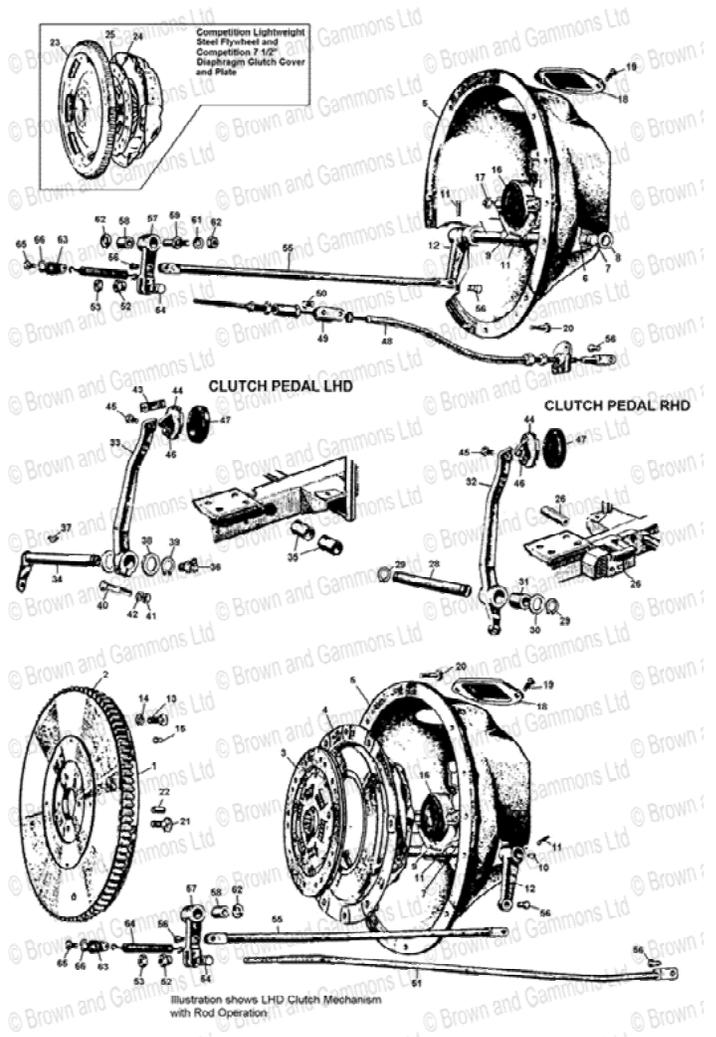
**Fig. 1 Detail view of right and left hand pedal shaft assemblies – from Brown and Gammons parts list.**

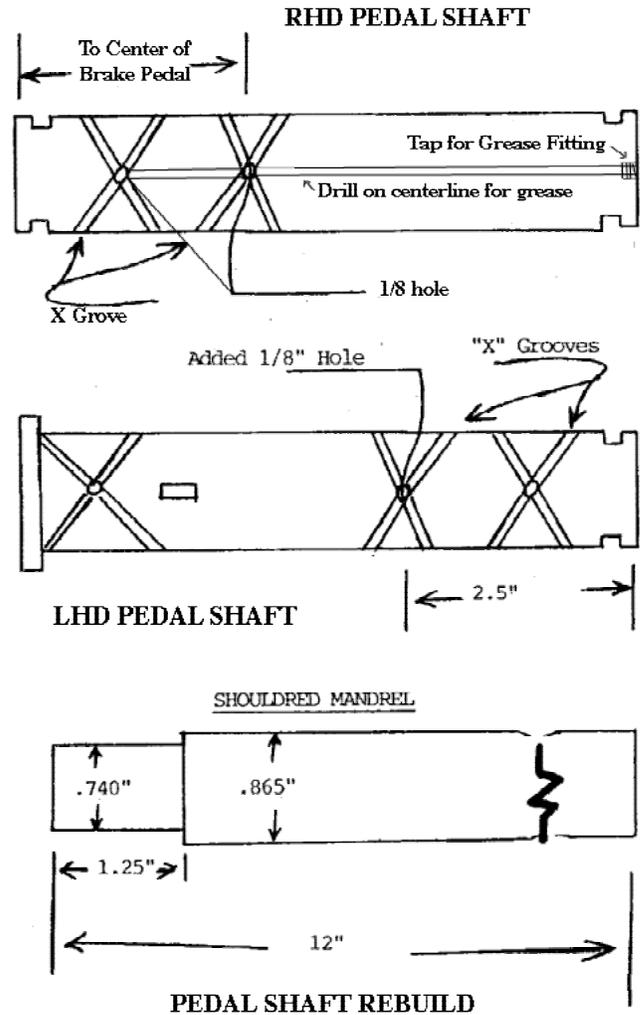
Fig. 7 Kellogg's Drawing with RHD Shaft added mgTalk, Vol. 11, No.2, February 1985

After receiving the new replacement shaft, I took it (and a copy of Richard's tech article) to my local machine shop with the request that they modify the shaft by drilling extra lubrication holes and cutting the three lubrication grooves. I decided to have them drill completely through the shaft for each of the three lubrication points – for a total of six lubrication exit points. Once all holes were drilled, the lubrication grooves were cut – one groove for each of the three sets of lubrication holes (see Fig. 5 and 6). This machine work cost \$30 dollars and I consider it money well spent. The six grease holes feature chamfered edges and these aid in distributing the grease once the bushings are in place over the exit holes in the shaft. When I tested the complete assembly on the workbench, I confirmed that, when pressured in by the grease gun, the grease would travel completely around all grooves and would spread out under the surface of each bushing. The tolerances are such that grease would travel to the absolute edge of the bushings. The pumping in of the grease filled the slight bit of clearance between the bushings and the shaft. This made for a very snug fit – just what we are after! With use, I think the coverage will be more than adequate. Richard's article mentions the cross hatch design for the lubrication grooves. I agree that this is the preferred pattern – as it promotes better surface coverage, see Fig. 7. I went with the simple grooves as these were easily cut by the machine shop and I had only one afternoon to modify the shaft before installation.
